**Aztec Property Inspections**  
**2719 Mission Blvd**  
**San Diego, CA 92109**  
**(858) 245-9329**

6352 Some Road  
San Diego, CA 92114

## Defective Summary

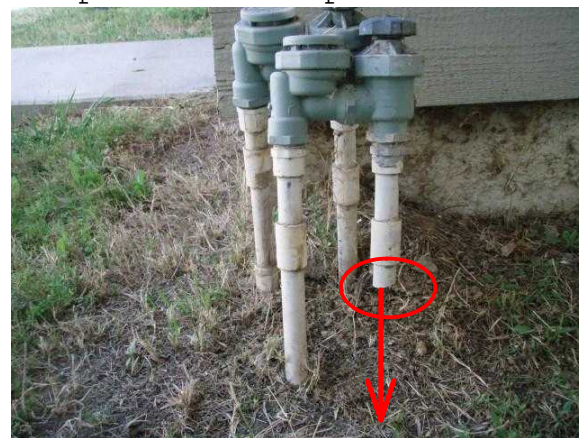
Marginal	Grading: The grading is not proper in one of more areas. This can result is water accumulating around the structure and it's foundation. Accumulated water is a conducive condition for wood destroying insects and organisms. Wet soil may also cause the foundation to settle and possible fail over time. Recommend grading the soil properly and or adding drainage.
Not Inspected	Exterior Surface Drain: Not tested. Beyond the scope of this inspection.
Not Inspected	Lawn Sprinklers: Not tested. Beyond the scope of this inspection. One or more water lines appear to be damaged. Correction is recommended.
Acceptable	Fences: Wood, Chain link Soil to wood contact was noted in one or more areas. This is a condition that is conducive to wood destroying organisms. Unfinished wood was noted in one or more areas. Stain and or finish is recommended. Gate needs adjustment in one or more areas. Correction is recommended. Damage and deterioration was noted in one or more areas. Correction is recommended.

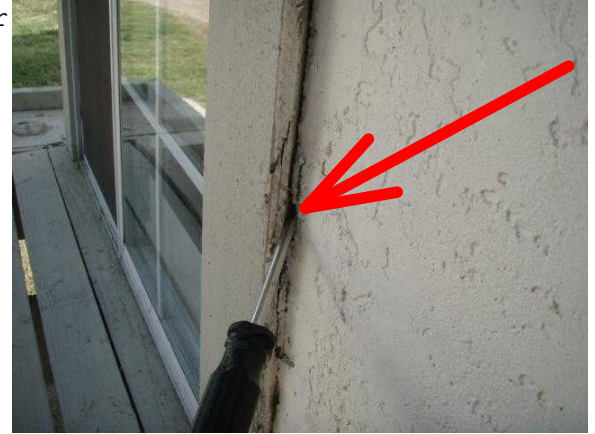
**Exterior Walls: Stucco, Wood siding** Gaps or holes not properly sealed at several areas. This can lead to moisture penetration and damage. This can also be used as a conduit for insects to enter the house. Recommend caulking these areas. Minor stucco damage was noted. Patch and repair was noted in one or more areas.

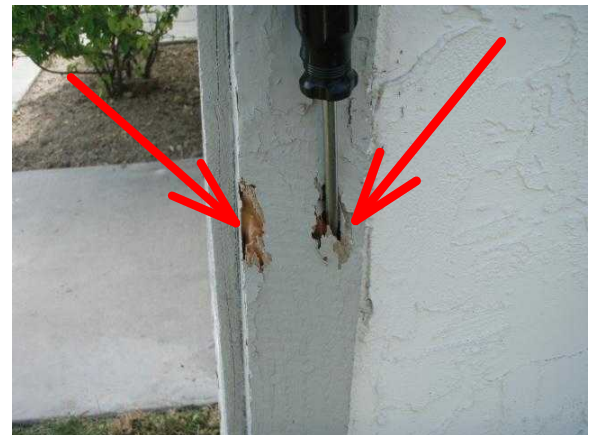
**Trim: Wood** The front planter box has fallen slightly away from the house. Termite and or dry rot damage was noted. Further evaluation is recommended by a licensed pest specialist. Gaps or holes not properly sealed at several areas. This can lead to moisture penetration and damage. This can also be used as a conduit for insects to enter the house. Recommend caulking these areas.

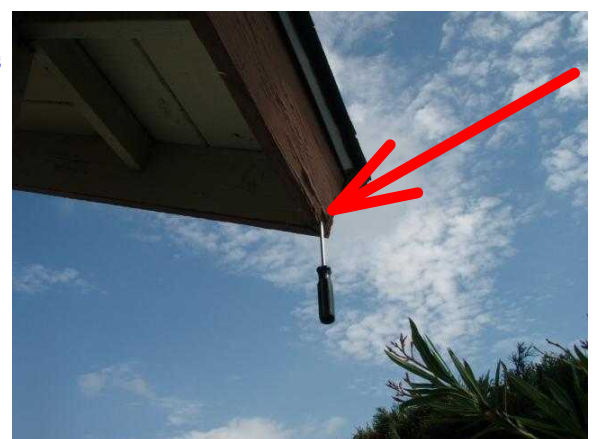
**Fascia: Wood** Termite and or dry rot damage was noted. Further evaluation is recommended by a licensed pest specialist.

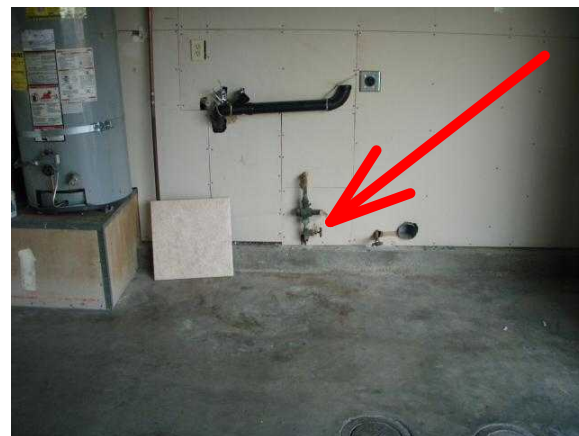
**Water Main Shutoff:** Garage The water shut off could not be viewed in utility box at the street. This could be the responsibility of the water utility company. Correction is recommended.

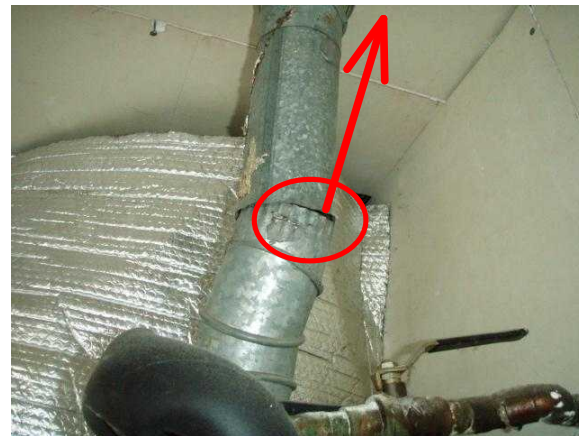
1. Garage Water Heater Flue Pipe: Disconnected vent pipe was noted. Correction is recommended.

**Defective, Safety Upgrade** **Flue Pipe:** Disconnected vent pipe was noted. Correction is recommended.

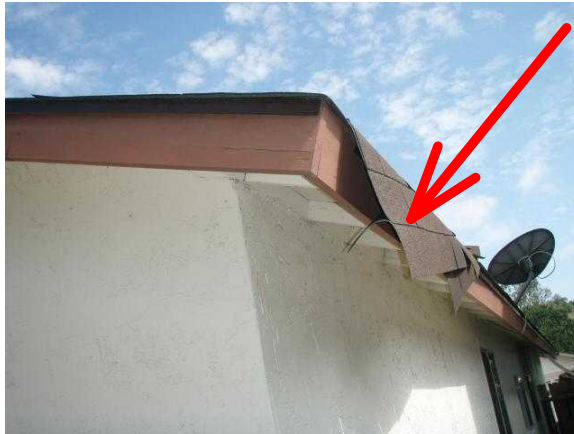
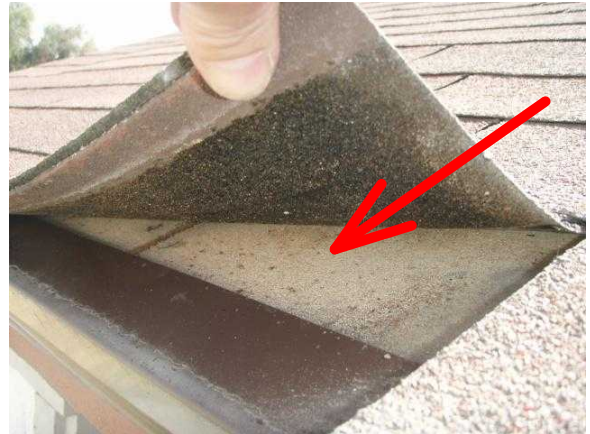
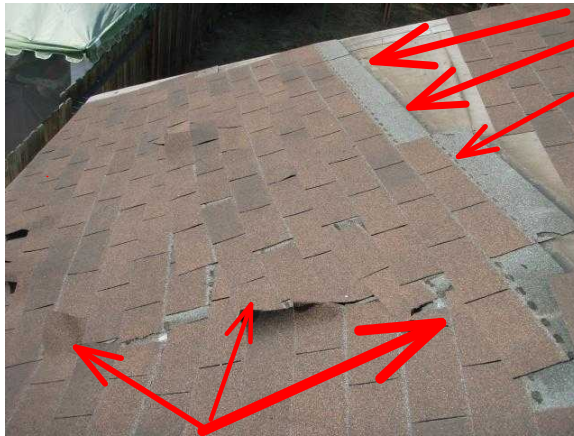
2. Roof Surface Material: Asphalt composite shingle No under layment could be viewed in one or more areas. The roof has been improperly installed. Damaged and or missing shingles noted. Damaged and or missing shingles noted. A qualified contractor is recommended to evaluate the entire roof and estimate repairs.

**Material:** Asphalt composite shingle No under layment could be viewed in one or more areas. The roof has been improperly installed. Damaged and or missing shingles noted. Damaged and or missing shingles noted. A qualified contractor is recommended to evaluate the entire roof and estimate repairs.

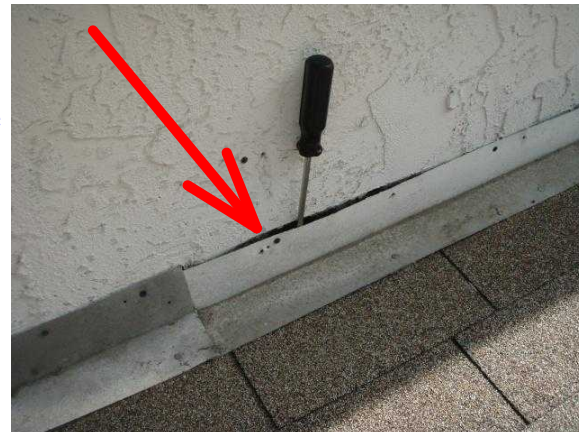
**Flashing:** Exposed fasteners were noted without mastic. These are possible moisture intrusion areas. Mastic is recommended on each nail head to ensure the water tightness of the roofing system. Improper roof flashing material noted. Improper installation of roof flashing noted. Further evaluation is recommended by a licensed roofer.

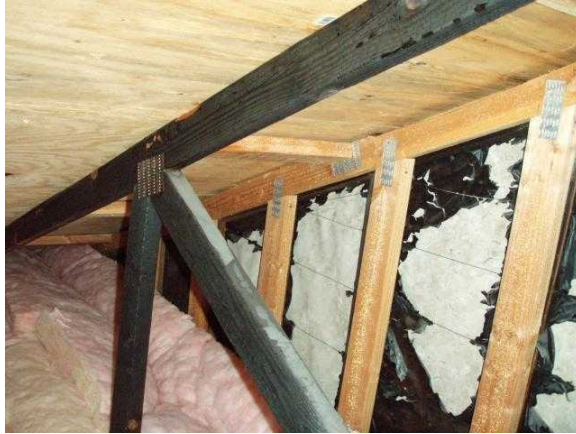
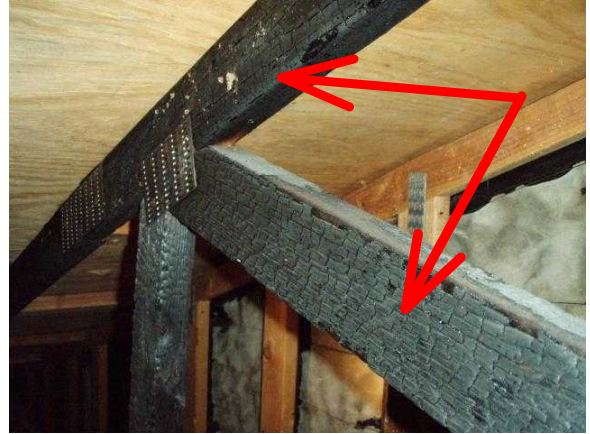
Marginal Roof Framing: 2x4 Truss Evidence of fire damage was noted in several areas. It appears that a new truss system has been installed and is charred in one or more areas. Inquire with the seller and the building department to see what what done and to make sure that the work was permitted.

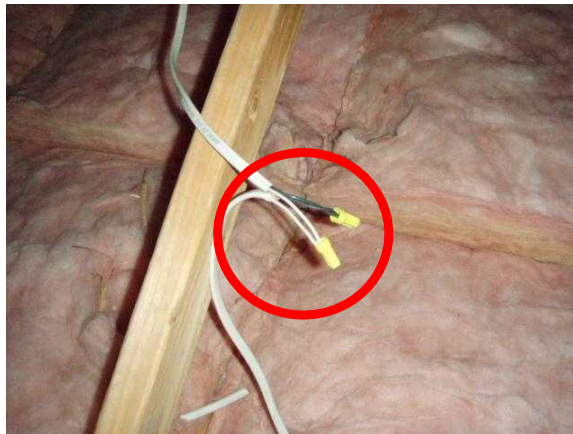
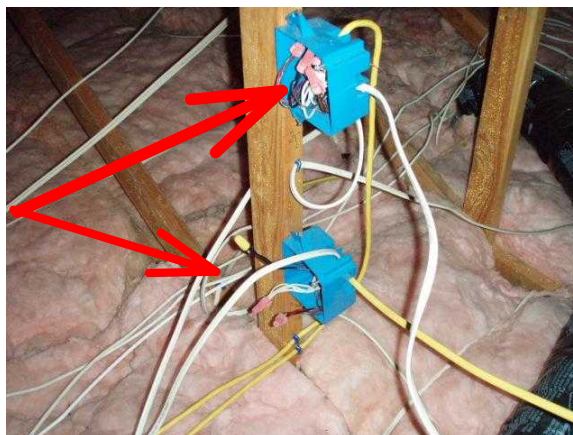
Wiring/Lighting: Open splices not in junction box noted. Further evaluation is recommended by a licensed electrician. Missing junction box covers were noted in one or more areas. Correction is recommended for added safety. Improperly terminated wires were noted in one or more areas.

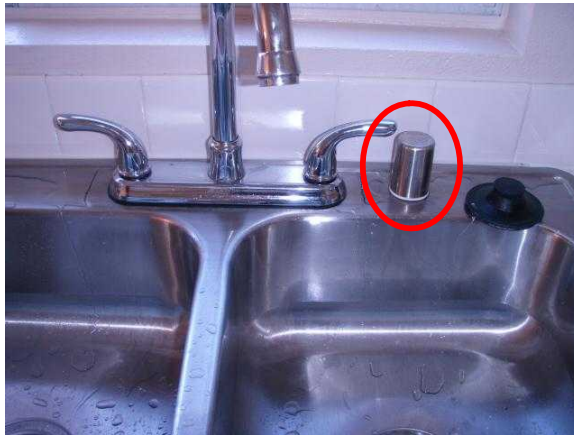
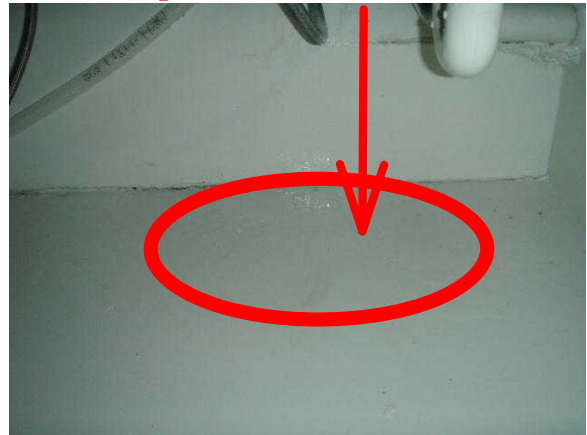
3. Kitchen Plumbing/Fixtures: A leak was noted from the dishwasher. A licensed plumber is recommended to evaluate and estimate repairs.

Not Inspected **Dishwasher:** Determining the adequacy of the washing and drying functions of the dishwasher is not a part of this inspection. A leak was noted from the dishwasher. The unit could not be properly inspected. The unit is not properly secured. Correction is recommended. Water was coming out of the at gap during the drain cycle. This is improper and correction is recommended.

Defective **Plumbing/Fixtures:** A leak was noted from the dishwasher. A licensed plumber is recommended to evaluate and estimate repairs.

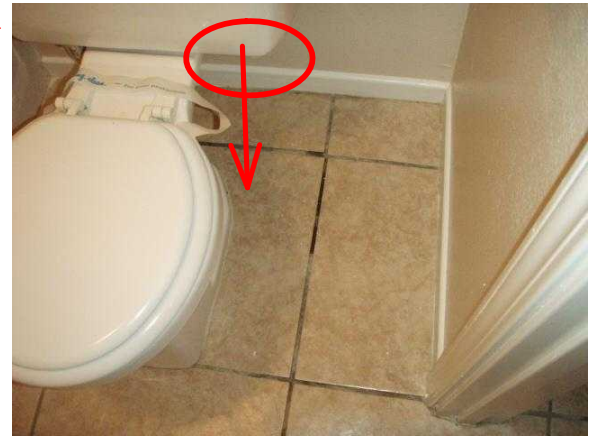
Toilets: A leak was noted from the tank. A qualified licensed contractor is recommended to evaluate and estimate repairs.

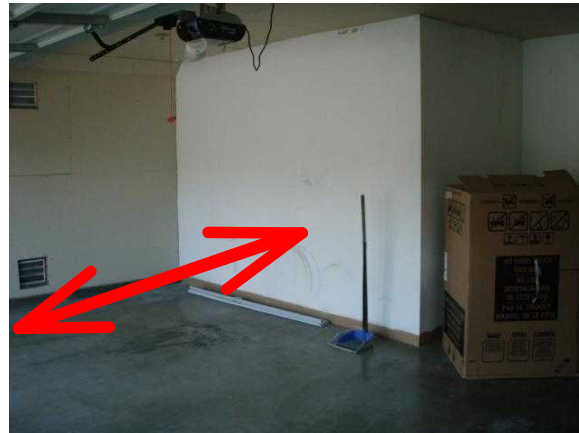
Vehicle Door(s) and Operation: The dept of the garage does not appear to be adequate for an average sized car due to an addition.
