**Aztec Property Inspections**  
**2719 Mission Blvd**  
**San Diego, CA 92109**  
**(858) 245-9329**

6352 Some Road  
San Diego, CA 92114

## Defective Summary

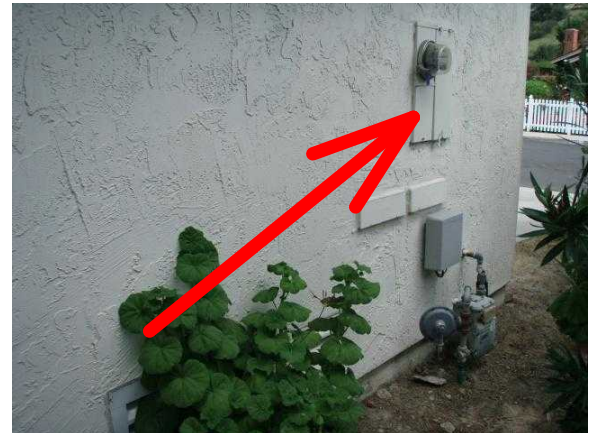
Not Inspected Service: Underground  
Acceptable Conductor Type: Romex  
South Corner Electric Panel  
Acceptable Ground: Not fully visible.
